GEUM ENVIRONMENTAL
CONSULTING, INC.

April 25, 2012

Subject: Clark Fork River Operable Unit of the Milltown Reservoir/Clark Fork River Superfund Site Pilot Streambank Treatment Project

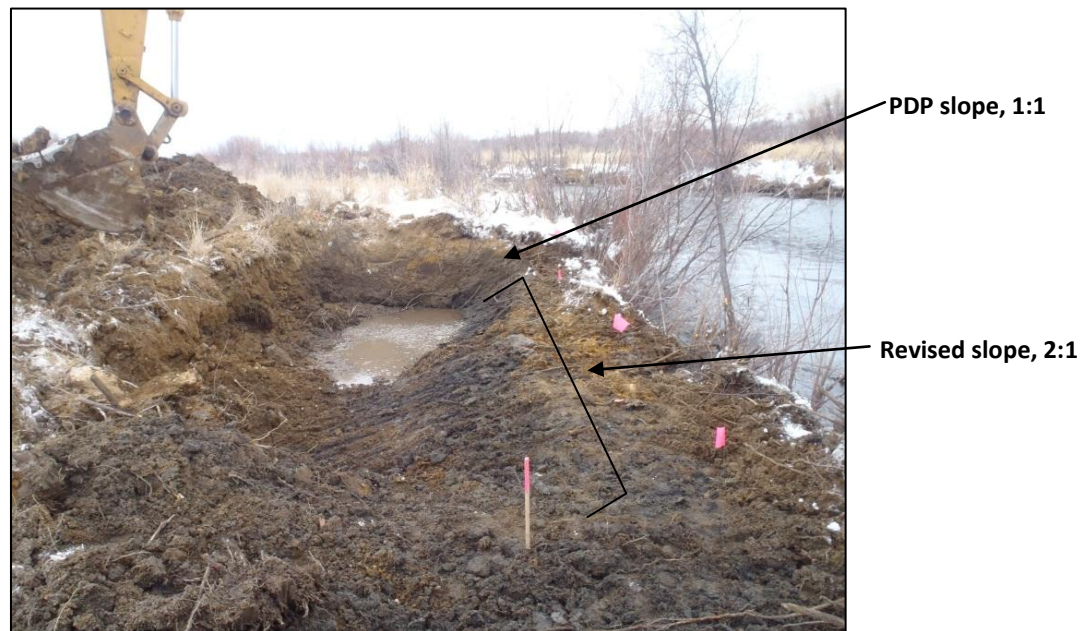
Figure 2. Type 2 streambank treatment showing the vegetated soil lift bench, trench and slope between the bench and trench.

- The trench slope should be 2:1 to facilitate backfill and staking of the soil lift, and placement of willow cuttings on the soil lift. Changing the slope will still provide willow cuttings to access perennial moisture.

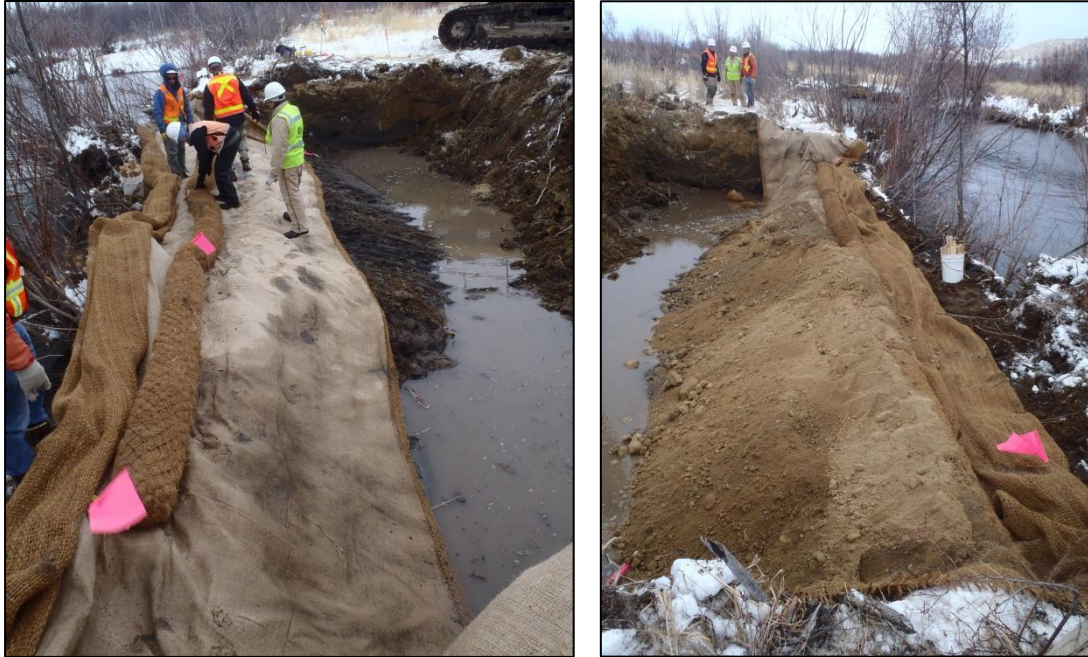
Figure 3. Materials used to construct the Type 2 bank treatment including double layer coir fabric, 12-inch normal density coir logs and vegetative backfill mixed with floodplain alluvium.

- A one-foot wide flat bench should be shown under the vegetated soil lift to support placement of the 12-inch normal density coir logs.
- The design willow cutting placement density of five per linear foot in the vegetated soil lifts seems appropriate.

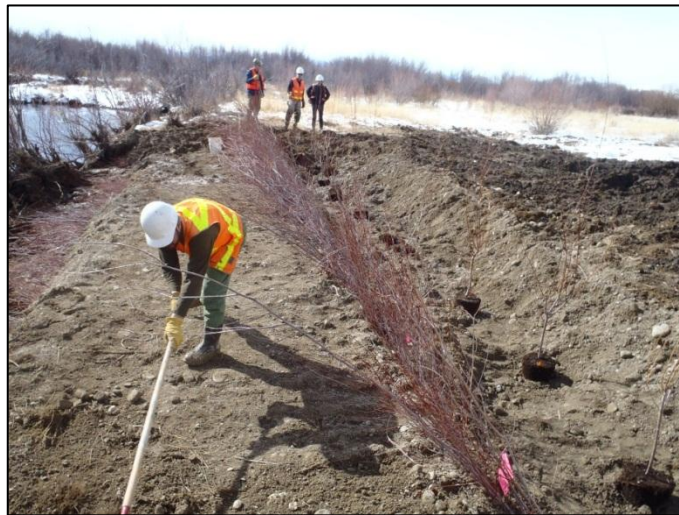
Figure 4. Placement of willow cuttings at interface between the bank treatment and the floodplain treatment and planting of eight-gallon container willows prior to placement of vegetative backfill.

- Placing willow cuttings at the interface of the bank treatment and floodplain treatment may not be necessary at all sites. For final design, cuttings should not be placed at this interface if the area will be planted with containerized plants.

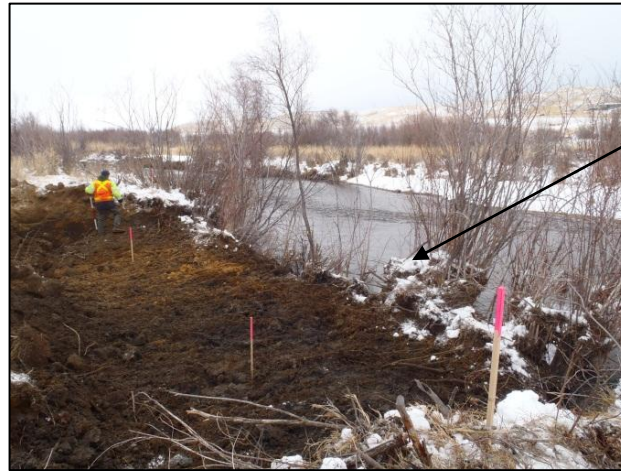
- A few preserved shrubs extended above the constructed bench elevation. Shrubs were preserved if the root ball was located less than one foot above design top of bank elevation (shown below).

Preserved vegetation located approximately 1 foot above final top of bank elevation

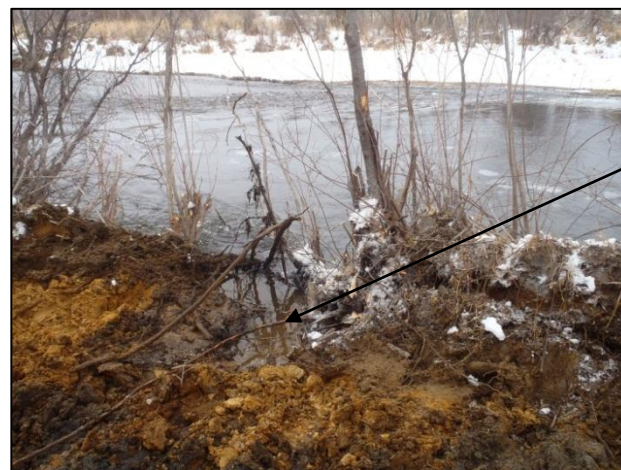
- One, three-foot wide gap in the bank vegetation was left after construction of the vegetated soil lift bench (shown below). This gap resulted in an area approximately 0.4 feet lower than the bench elevation. Because the soil lift bench was set back approximately two feet from the edge of the bank, there was no need to fill this gap with woody debris as shown for gaps in vegetation on Drawing D-2, Detail C in the PDP. Other sites where gaps leave deeper holes will require placement of alluvium and woody debris prior to construction of the vegetated soil lift.

Gap in bank vegetation after excavation of vegetated soil lift bench

- Not excavating below the design bank elevation directly behind preserved bank vegetation and leaving one to two feet of intact existing bank before excavating the vegetated soil lift bench. This will reduce the risk of erosion behind the preserved vegetation and possibly maintain stability for preserved vegetation.

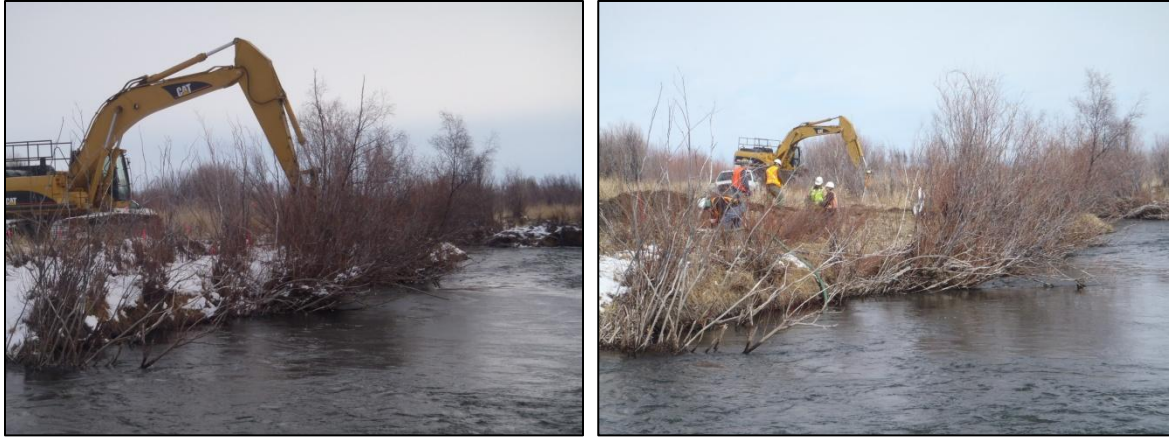
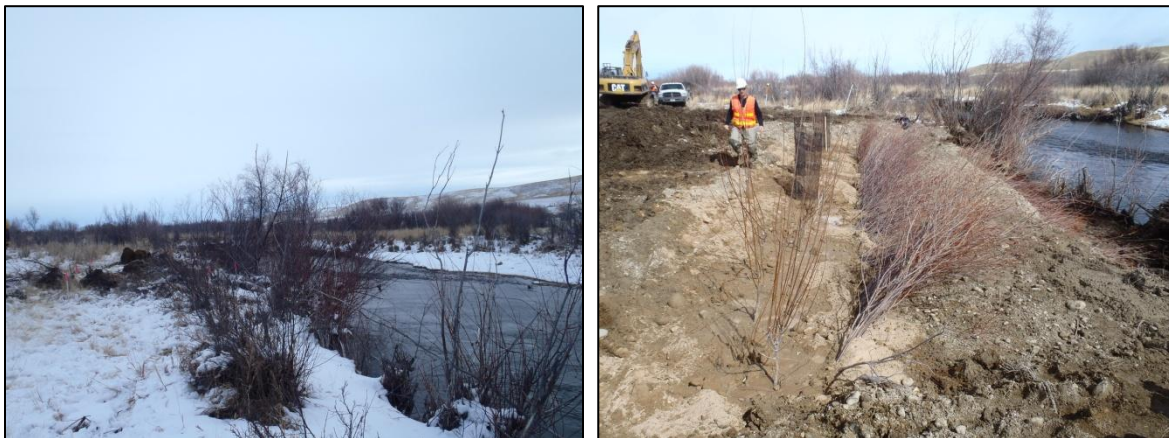
- Preserved woody vegetation is well rooted into the banks and rooted below the maximum excavation depth.
- The vegetated soil lift bench substrate consisted of sandy loam soil with some clay held together by woody vegetation. The area between the preserved vegetation at the bank line and the face

of the vegetated soil lift should be monitored for erosion, deposition, and natural colonization. The site was observed one week after installation and some cracks were present in this area. It did not appear that the cracks were caused by slumping of the preserved vegetation.

Figure 5. Type 2 bank treatment site prior to installation of the treatment (photo left) and after installation of the treatment (photo right).

Figure 6. Type 2 bank treatment site prior to installation of the treatment (photo left) and after installation of the treatment (photo right).

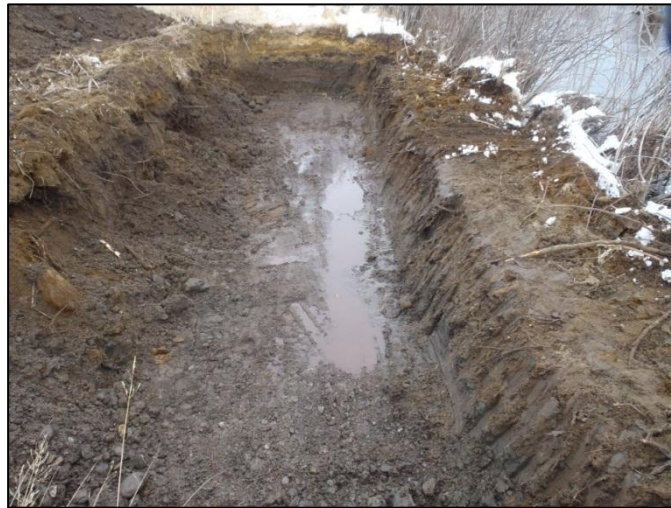
Figure 7. Modified Type 2 bank treatment excavation.

- The native bank substrate consisted of clay loam.
- Based on observations of soil color alone (obvious soil contamination being bright orange or yellow in color), it appeared that excavation of material to the design top of bank elevation and within two feet of the bank resulted in removal of most contamination (soil profile seen at top of photo in Figure 7).

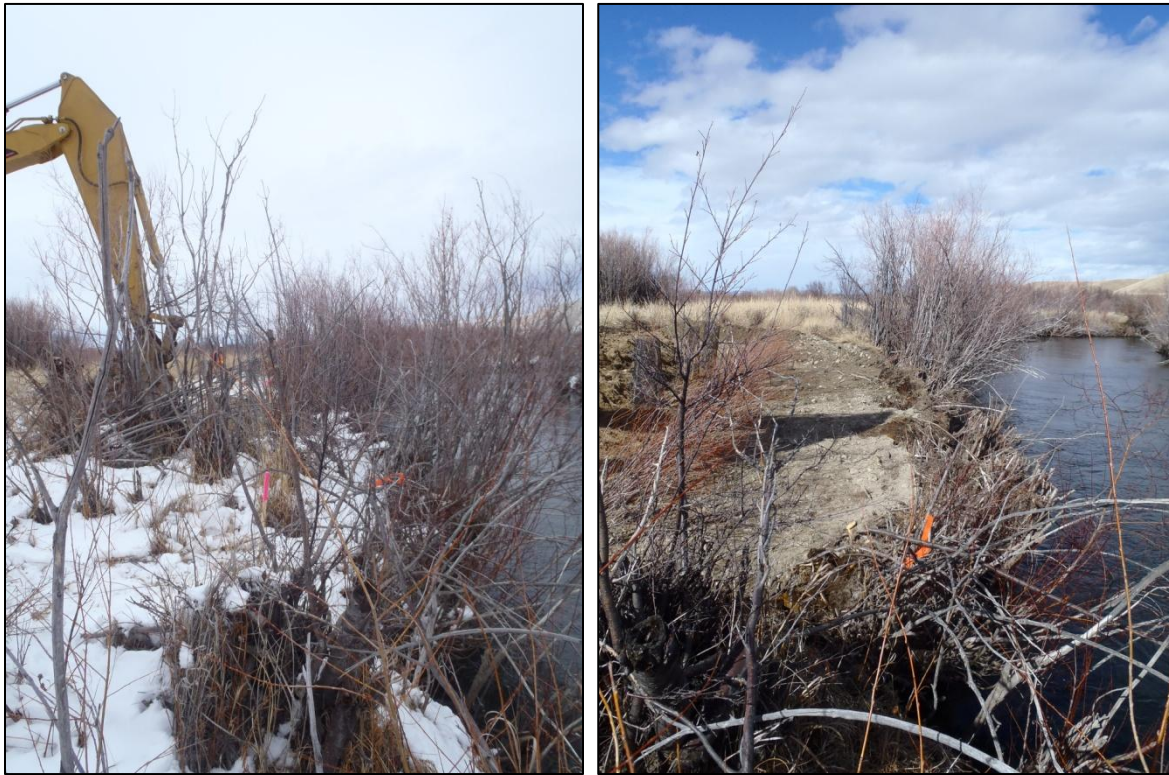
Figure 8. Modified Type 2 bank treatment site prior to construction (photo left) and after construction (photo right).

Based on these observations, it is recommended that wherever feasible the Type 2 bank treatment is changed to the Modified Type 2 bank treatment for final design. The Modified Type 2 bank treatment would have the following design elements:

- Excavation of existing vegetation to the top of bank design elevation.

- Excavation to the base of tailings plus 0.5 feet excavation depth. Excavation should leave two feet of existing material in place immediately behind the preserved vegetation.

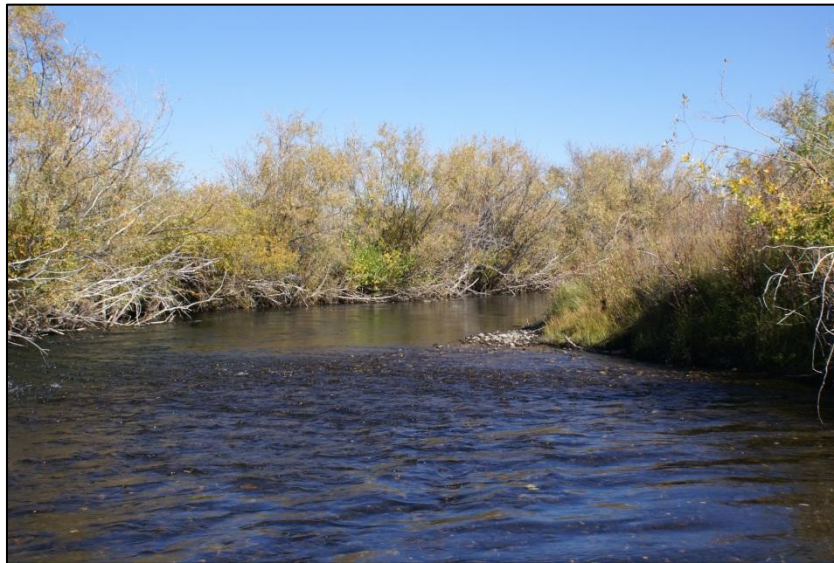
Figures 9 and 10 illustrate banks that initially were designated as Type 2 bank treatments in the PDP but meet the criteria listed above for the Modified Type 2 treatment. Figure 11 illustrates a Type 2 bank treatment site that was modified to a Type 3 bank treatment (double vegetated soil lift) during the April 4, 2012 design team field visit. Figure 12 illustrates a Type 3 bank treatment site. The changes to bank treatment designations will be incorporated into the final design for the Phase 1 project.

Figure 9. Bank designated in the PDP as Type 2 bank treatment (single vegetated soil lift) that was changed to a Modified Type 2 bank treatment (preserve vegetation) based on criteria determined by design team after implementation of the streambank pilot project.

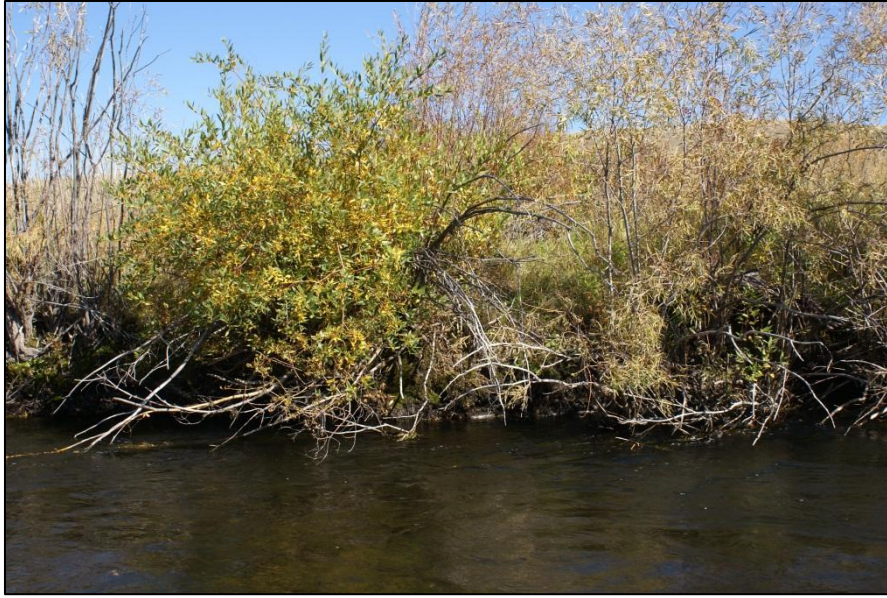
Figure 10. Bank designated in the PDP as Type 2 bank treatment (single vegetated soil lift) and changed to Modified Type 2 bank treatment (preserve vegetation) based on criteria determined by design team after implementation of the pilot project.

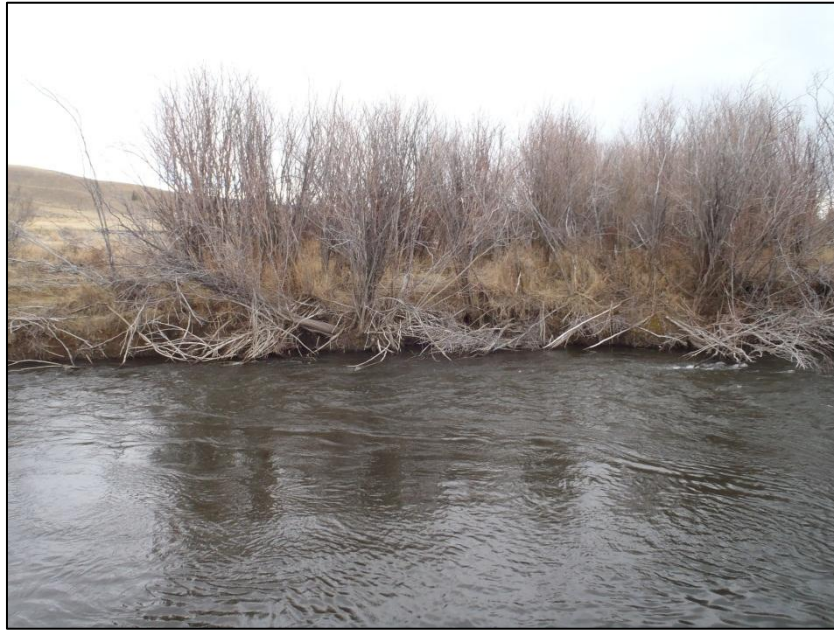
Figure 11. Type 2 bank treatment (single vegetated soil lift) site located on the right bank at station 88+00 that was changed to the Type 3 (double vegetated soil lift) bank treatment. Vegetation is mostly decadent, the bank consists of sandy material, and the toe is eroding.

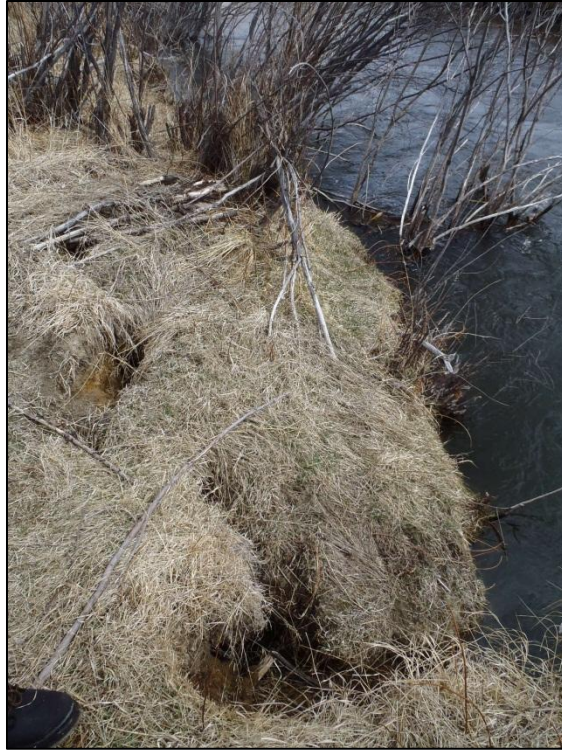
Figure 12. Non-cohesive bank material and unstable toe at station 68+00. This location is designated as a Type 3 bank treatment (double vegetative soil lift).
